**Historic Bridge Rehabilitation Analysis Phase 1
SR 1002 (Skinners Falls Road) over Delaware River**

BMS# 63-1002-0230-0739

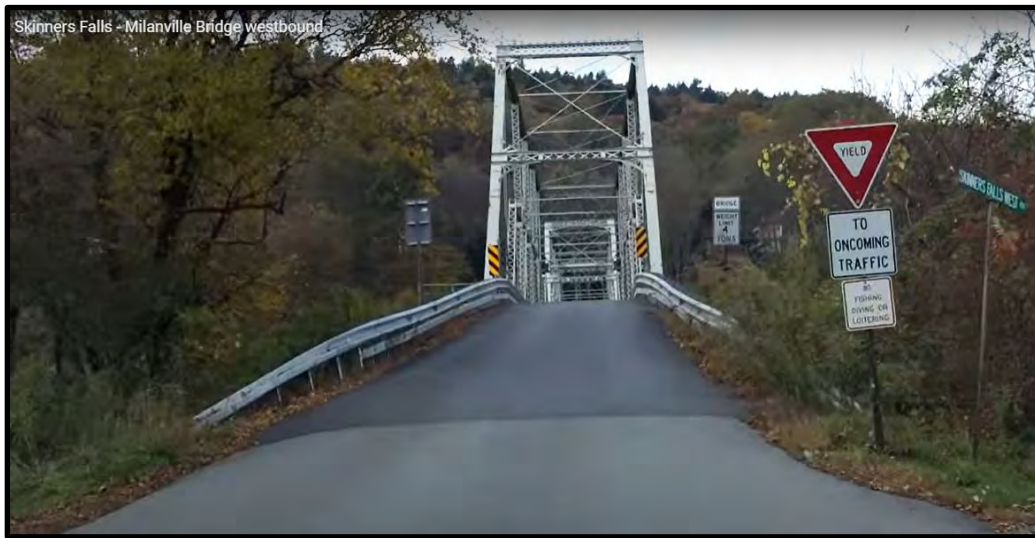
Figure 2: New York Approach geometry with a view west of the approach on the east (New York) side of the bridge.

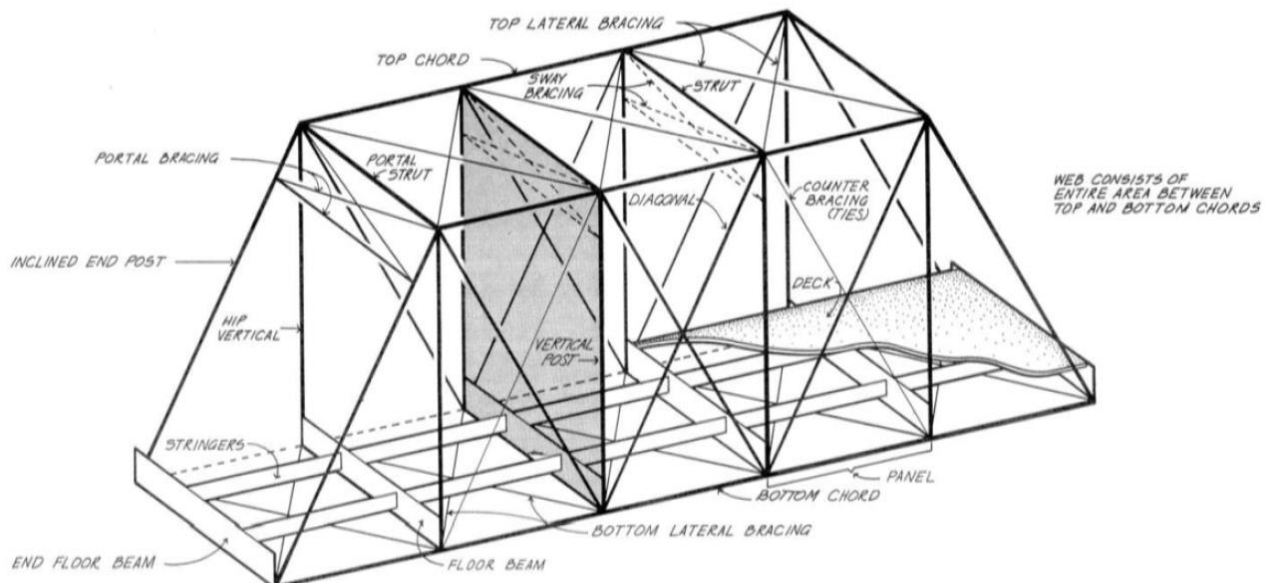
Figure 3: Basic Truss Components (from PennDOT Truss Maintenance Manual, 2015)

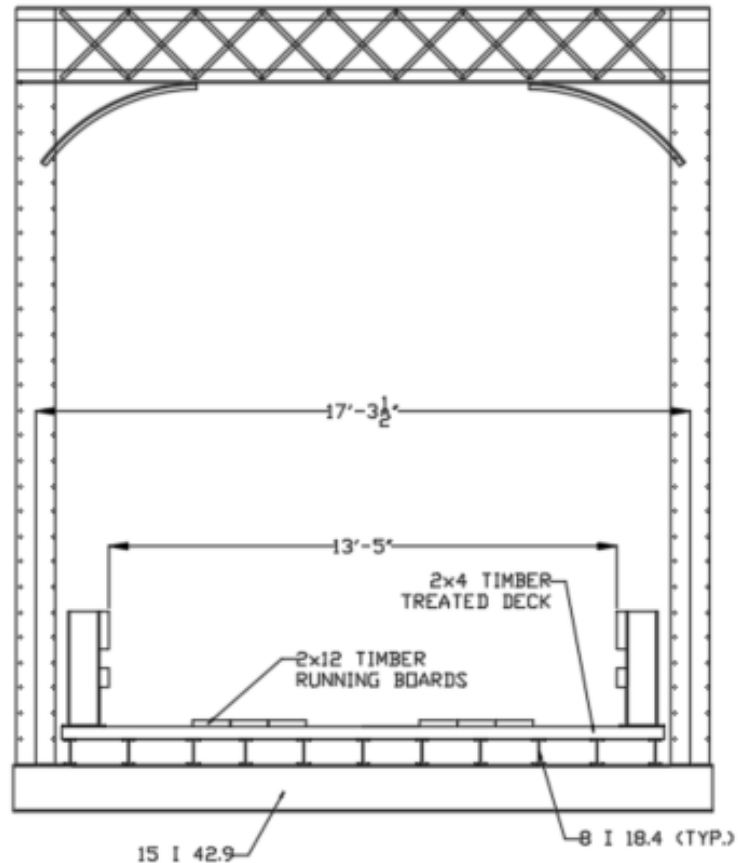
Figure 6: Existing Skinnners Falls Bridge Cross Section

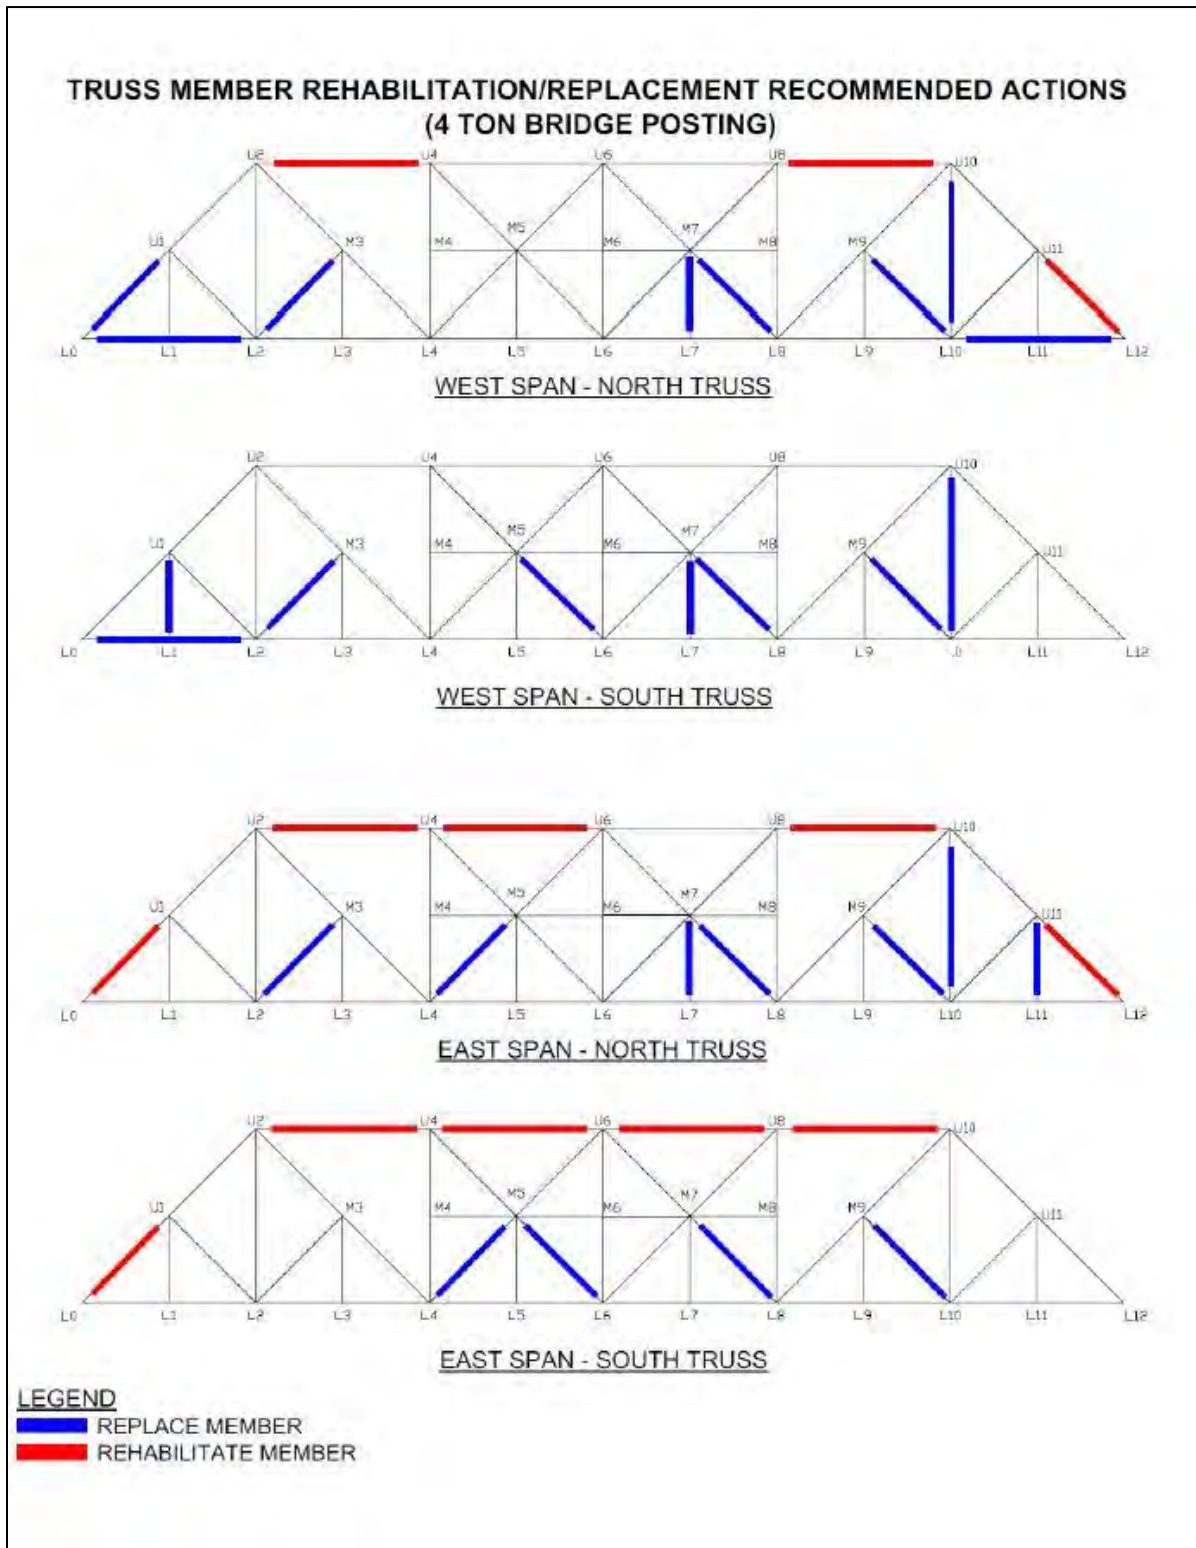
Figure 7: Minimum Rehabilitation (4-ton) Alternative

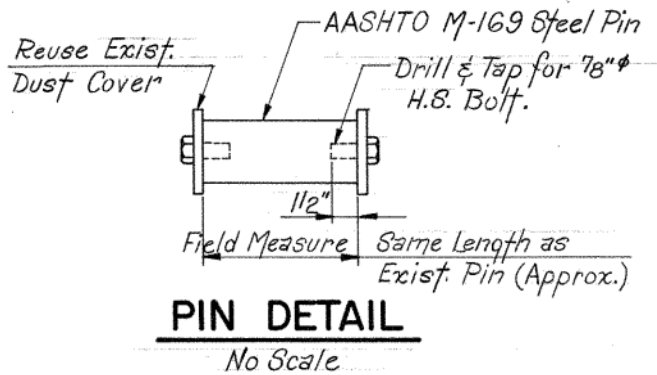
Figure 8: Existing Pin Detail, 1986 Rehabilitation Drawings

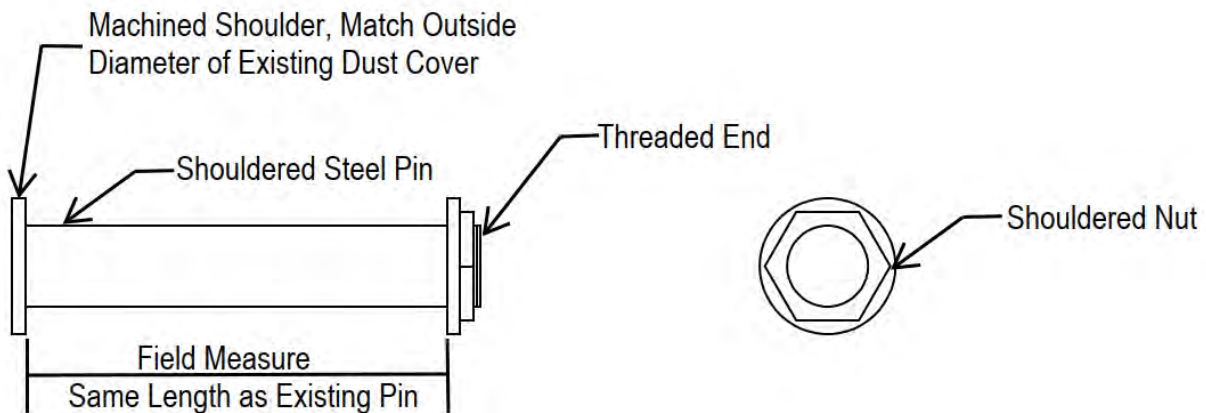
Figure 10: Proposed Shouldered Pin Detail and Shouldered Nut Detail

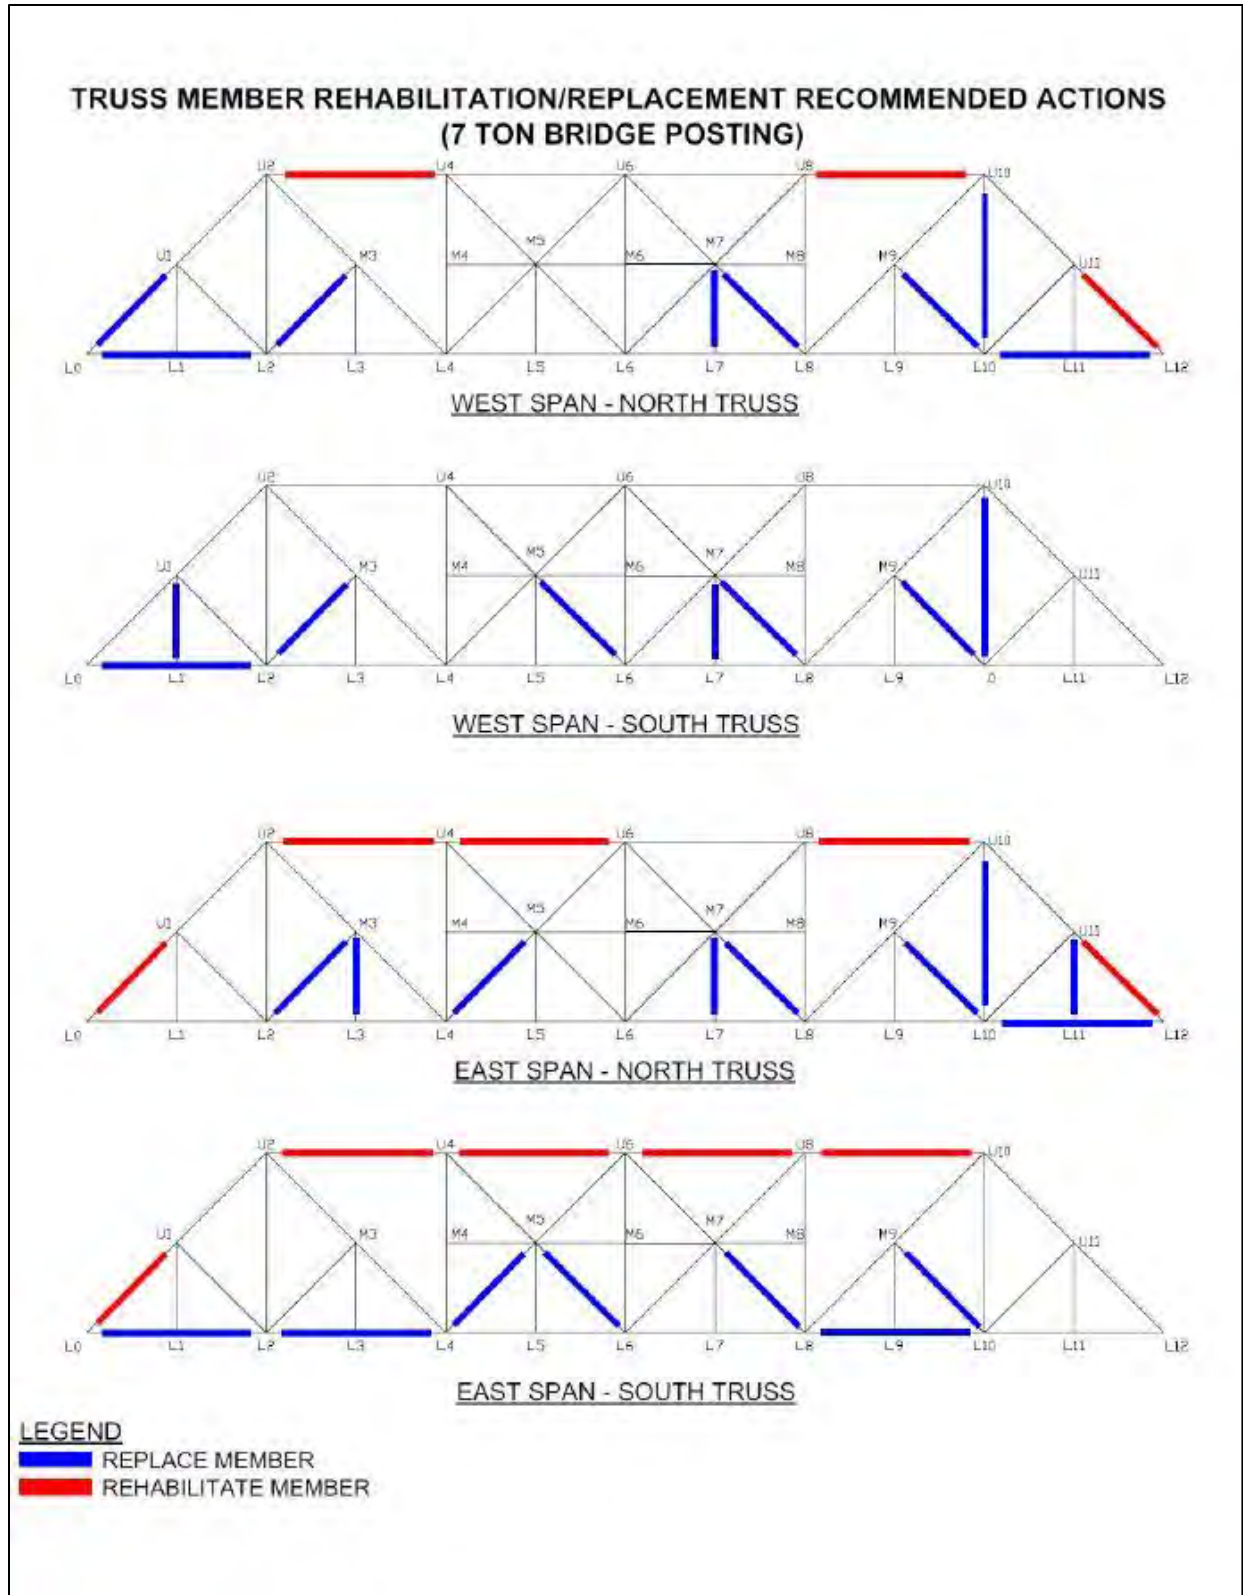
Figure 11: 7-ton Rehabilitation Alternative

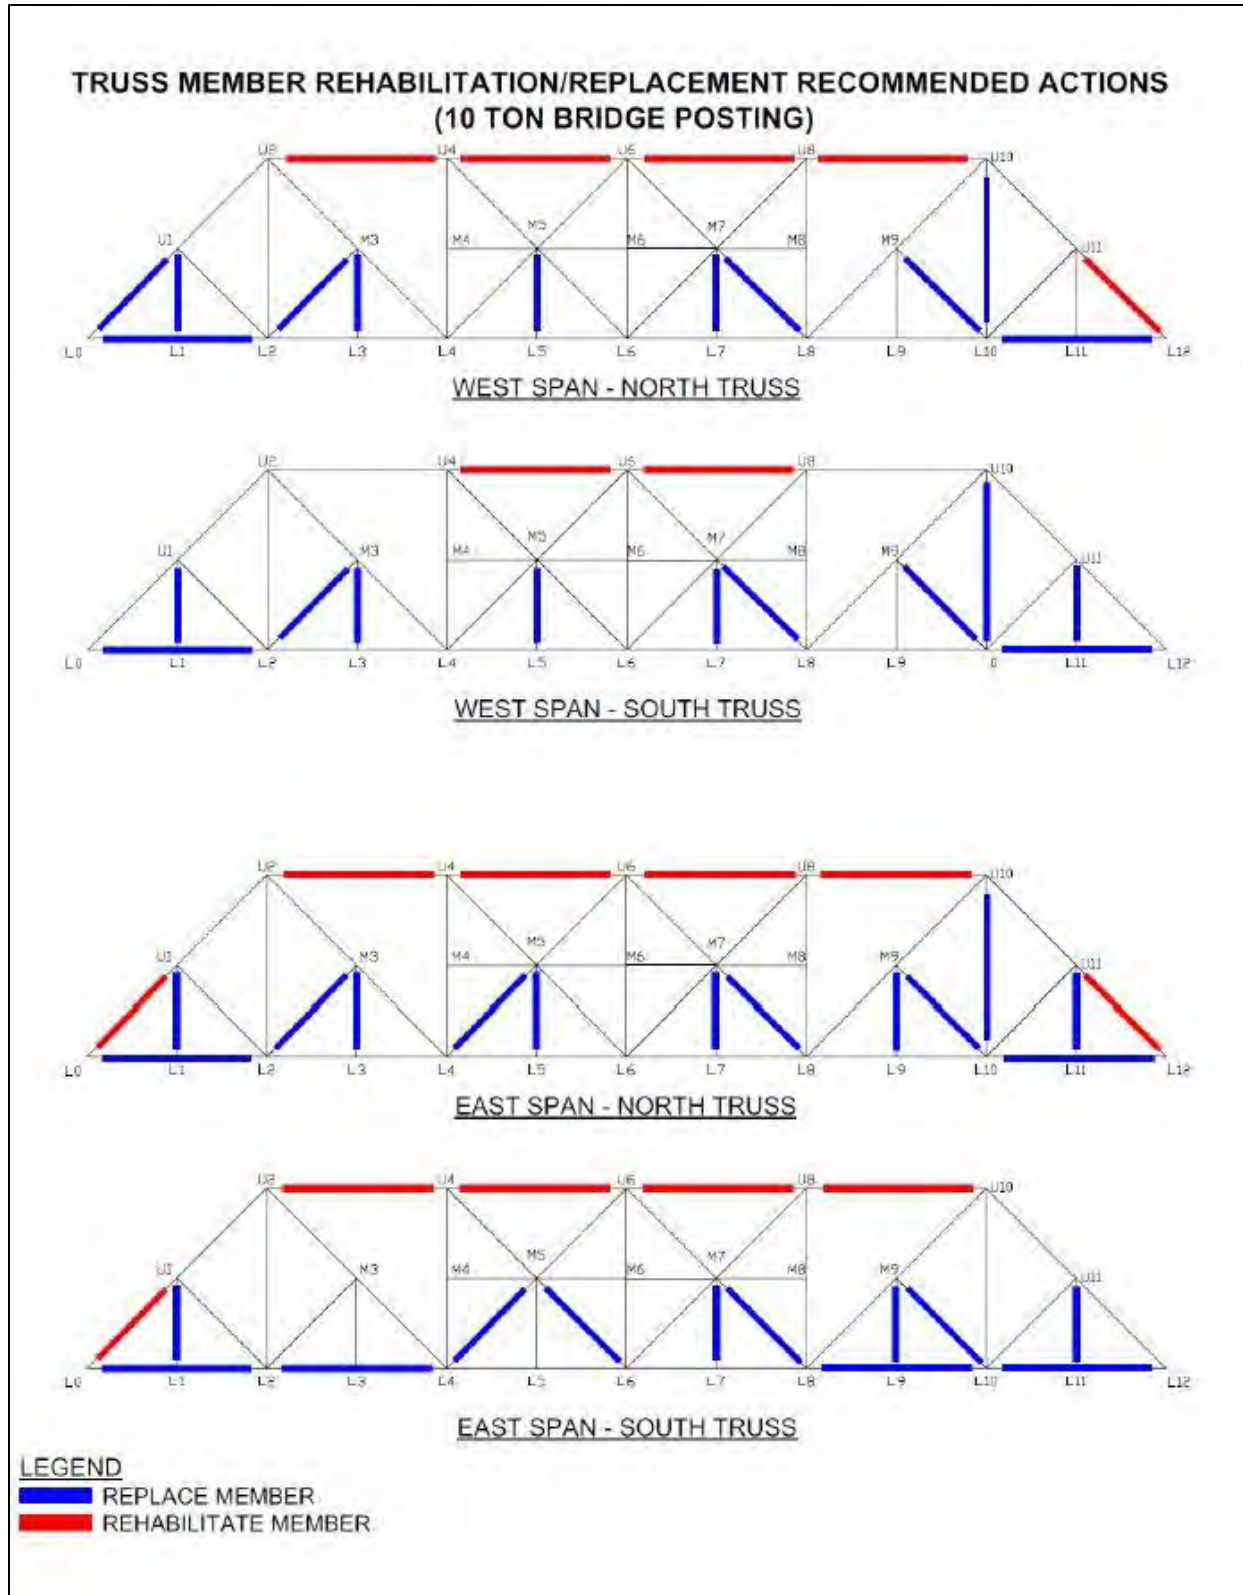
Figure 12: 10-ton Rehabilitation Alternative

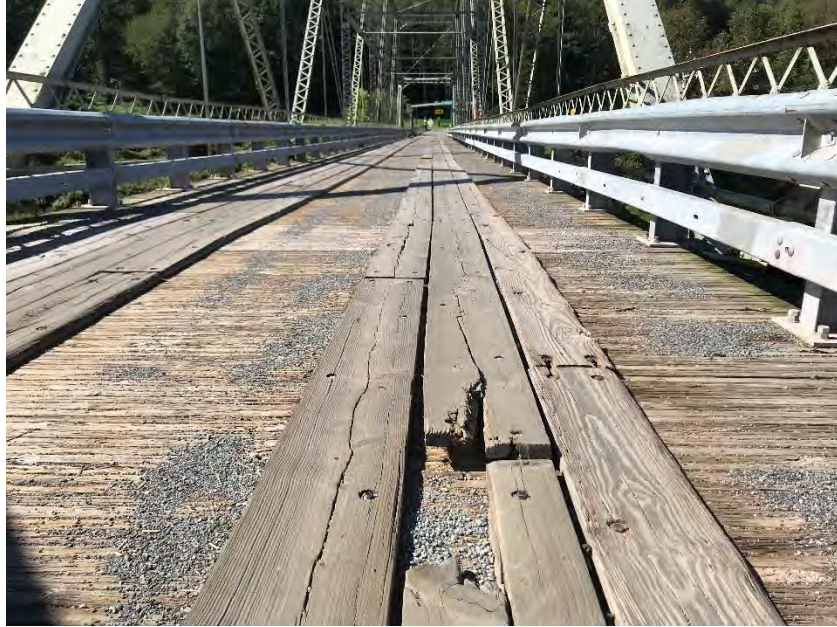
Photo 5 - Skinnners Falls Bridge: Timber Running Board Deterioration

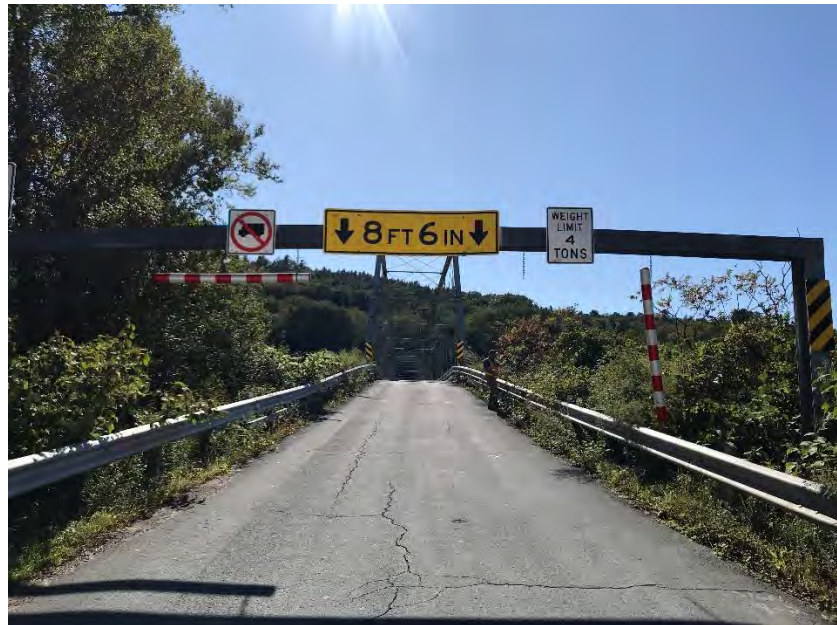
Photo 6 - Skinnners Falls Bridge: Headache Bar at NY Approach

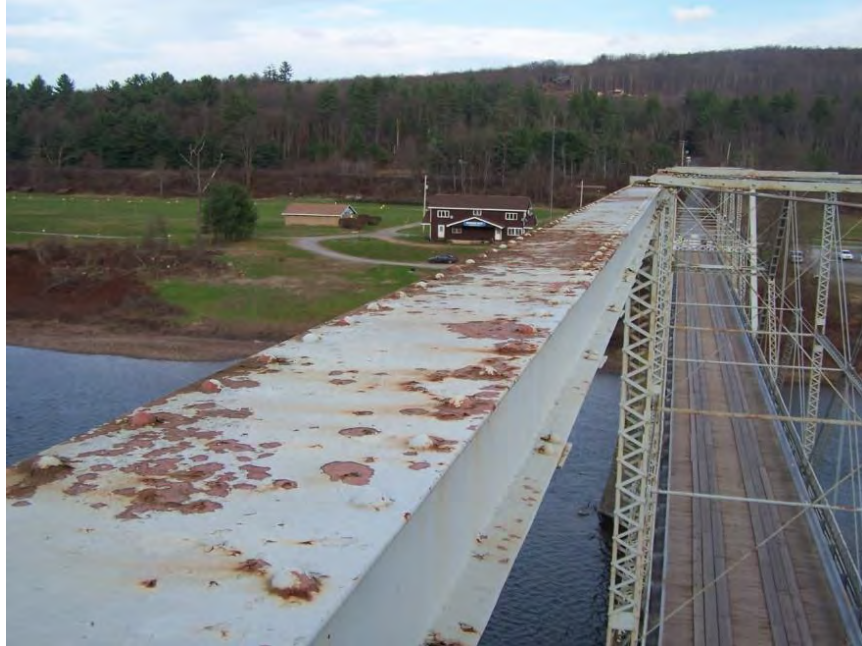
Photo 9 - Skinnners Falls Bridge: Left Truss Top Chord flaking paint and minor surface rust

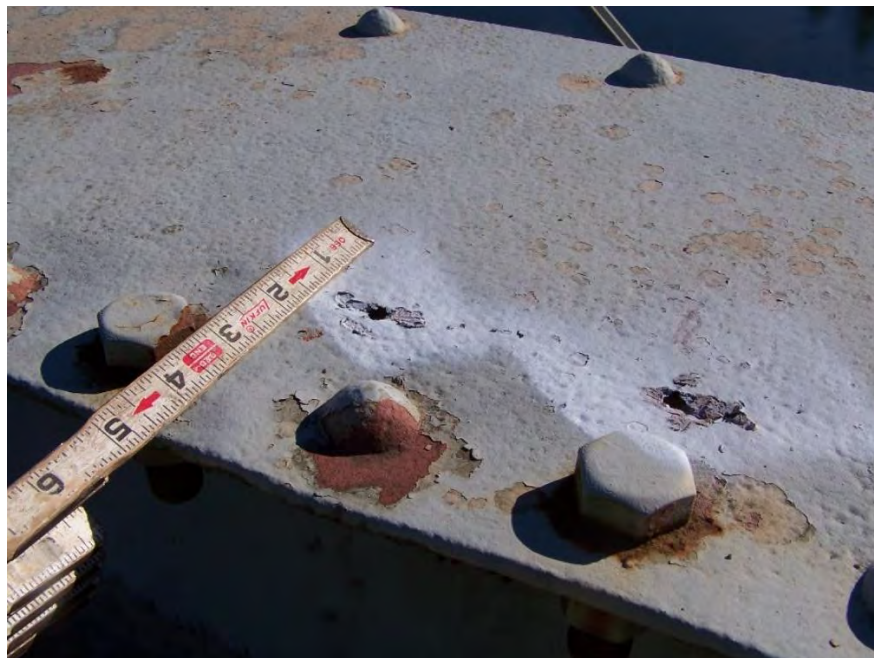
Photo 10 - Skinnners Falls Bridge: Left Truss Top Chord section loss

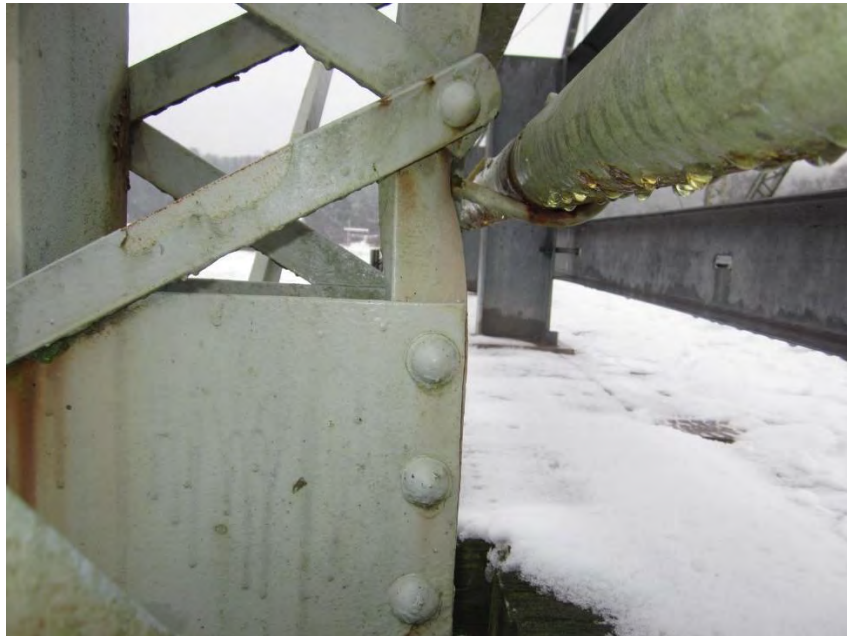
Photo 12 - Skinners Falls Bridge: Collision damage to vertical members at deck level behind the bridge railing

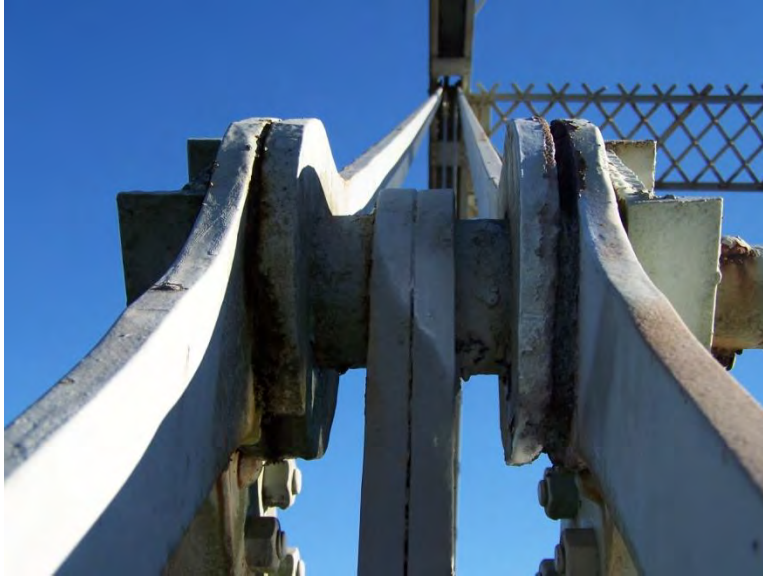
Photo 13 - Skinners Falls Bridge: Typical losses to eyebar heads at middle panel points

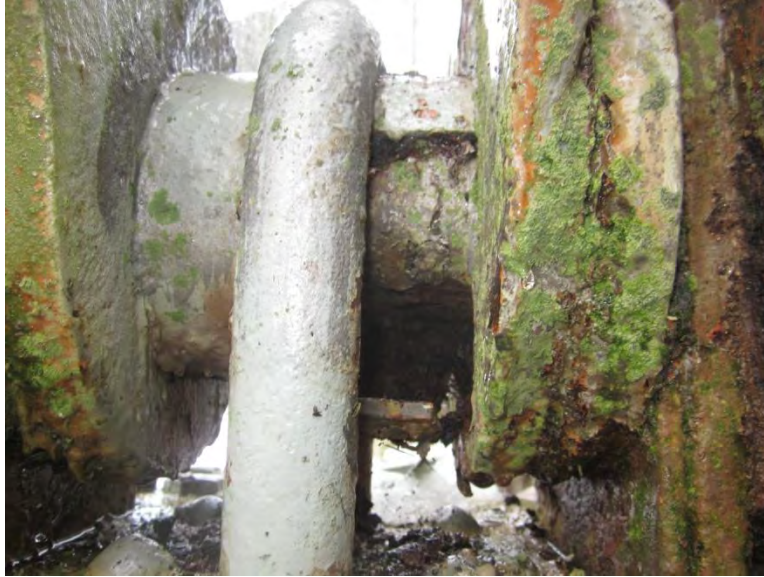
Photo 17 - Skanners Falls Bridge: Span 1, Left Truss, Panel Point L6 pin sleeve broken (Looking Ahead)

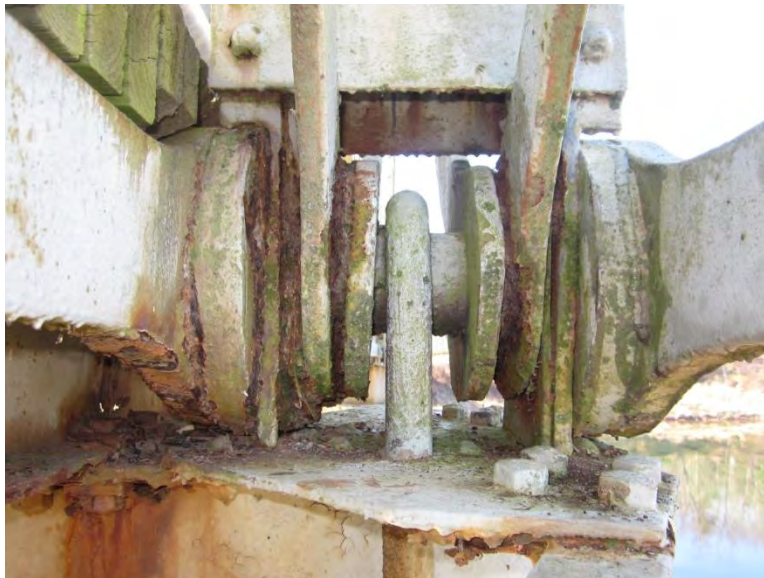
Photo 18- Skanners Falls Bridge: Span 2, Left Truss, Panel Point L6 extensive pack rust (Looking Back)

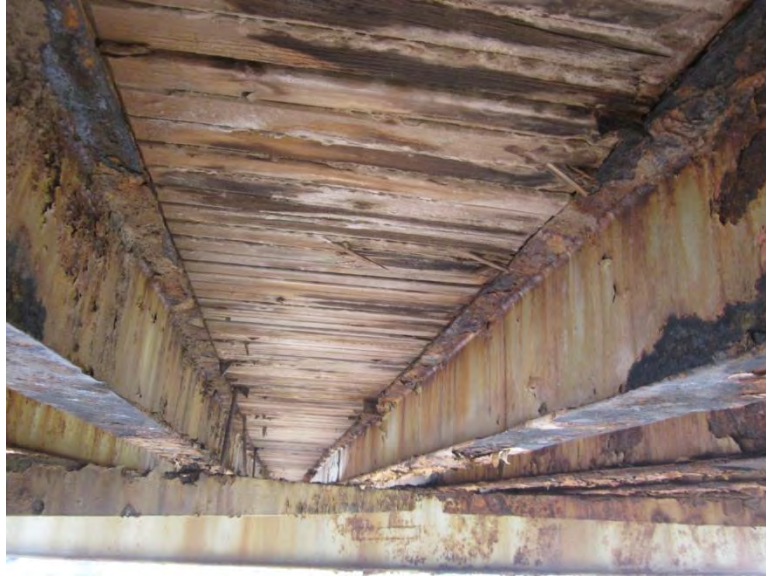
Photo 19 - Skinnners Falls Bridge: Typical deck underside condition. Note missing clips

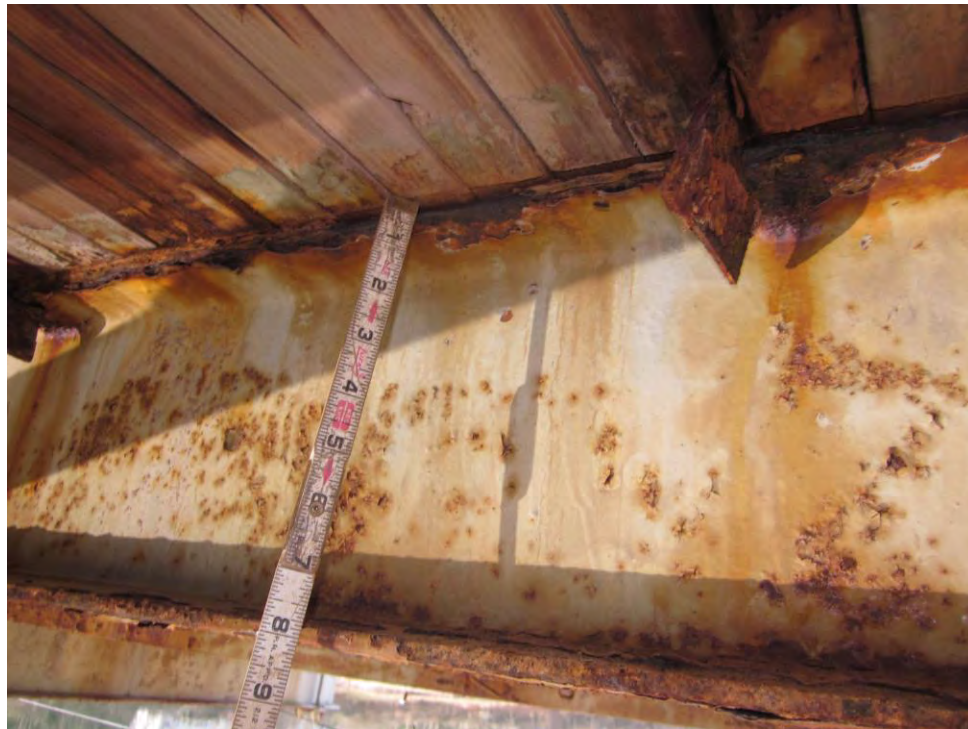
Photo 20 - Skinnners Falls Bridge: Gap between stringer and deck due to section loss

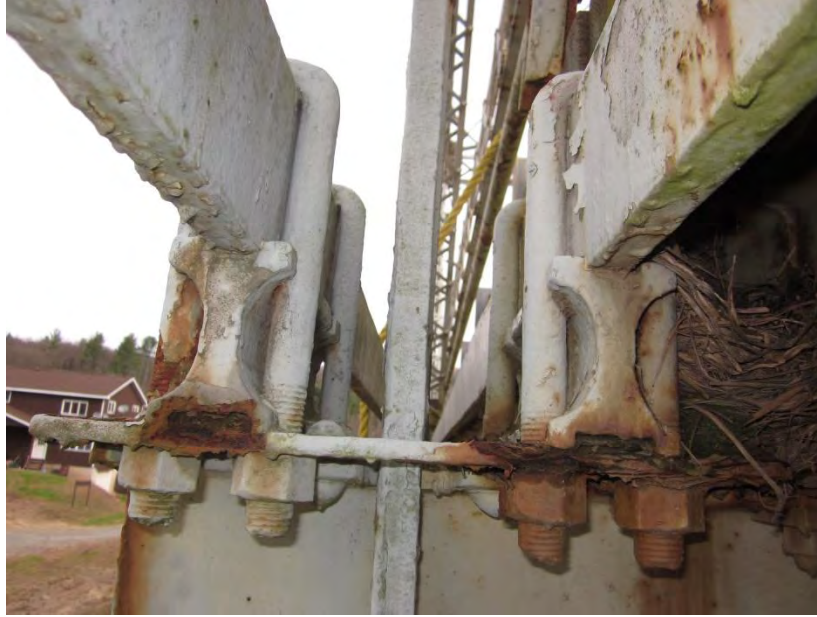
Photo 21 - Skinnners Falls Bridge: Floor Beam Support deterioration

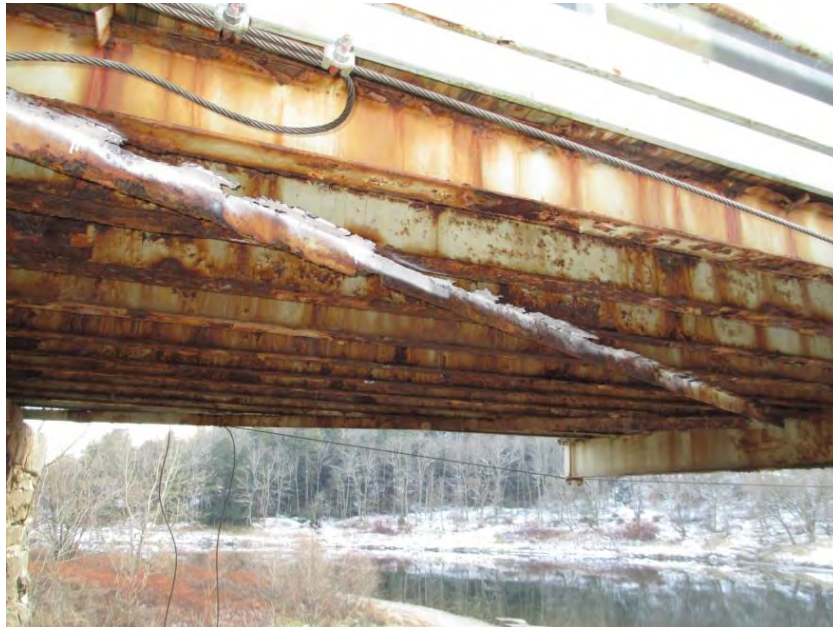
Photo 22 - Skinnners Falls Bridge: Span 2, Floor Beam Bay 12, 100% section loss to bottom lateral bracing

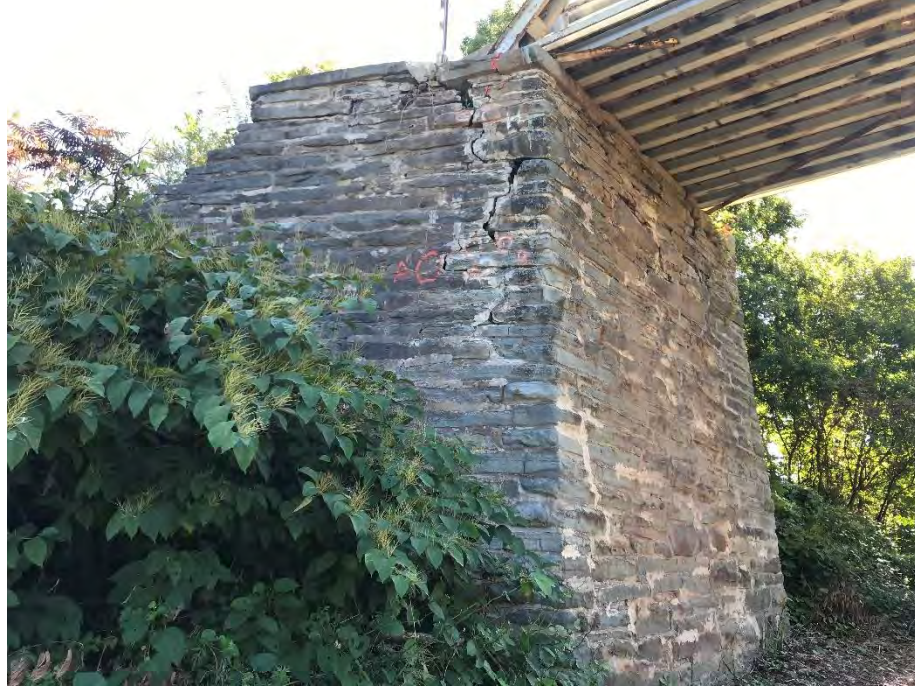
Photo 23 - Skinners Falls Bridge: Far Left Wingwall with Crack Monitoring Points and Full Height Step Cracking

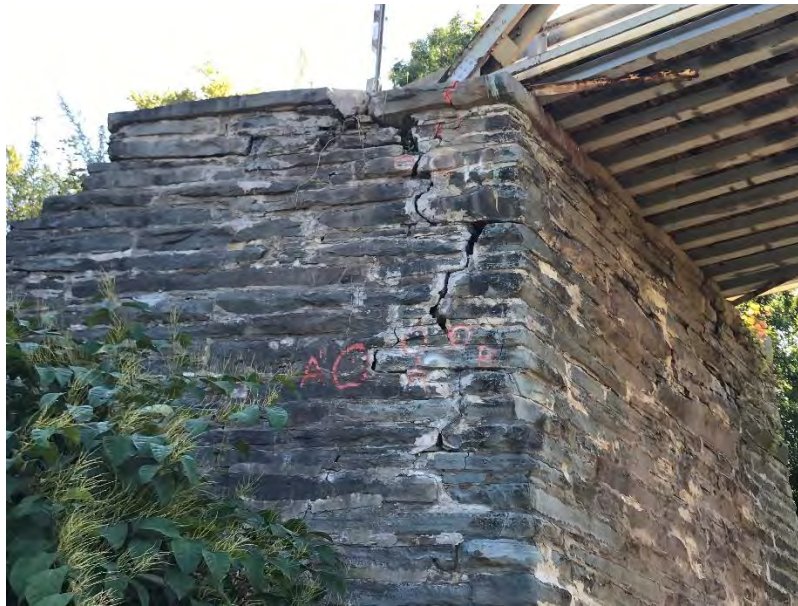
Photo 24 - Skinners Falls Bridge: Far Left Wingwall with Crack Monitoring Points and Full Height Step Cracking

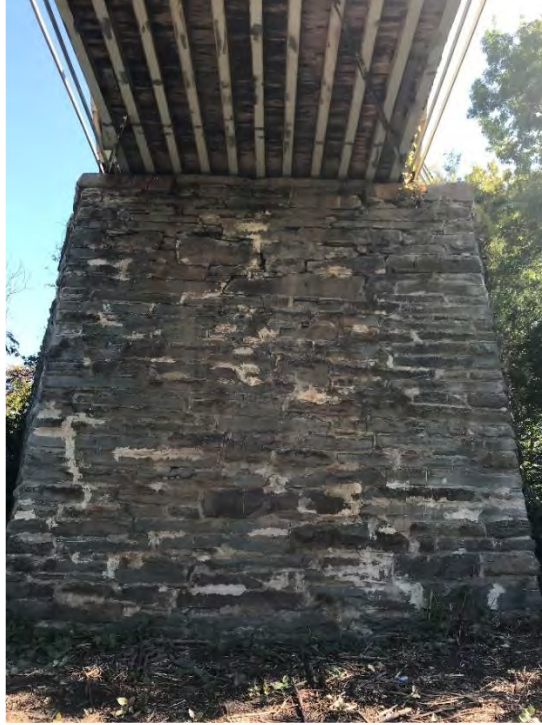
Photo 25 - Skinners Falls Bridge: Far Abutment with Crack Monitoring Points and Full Height Step Cracking

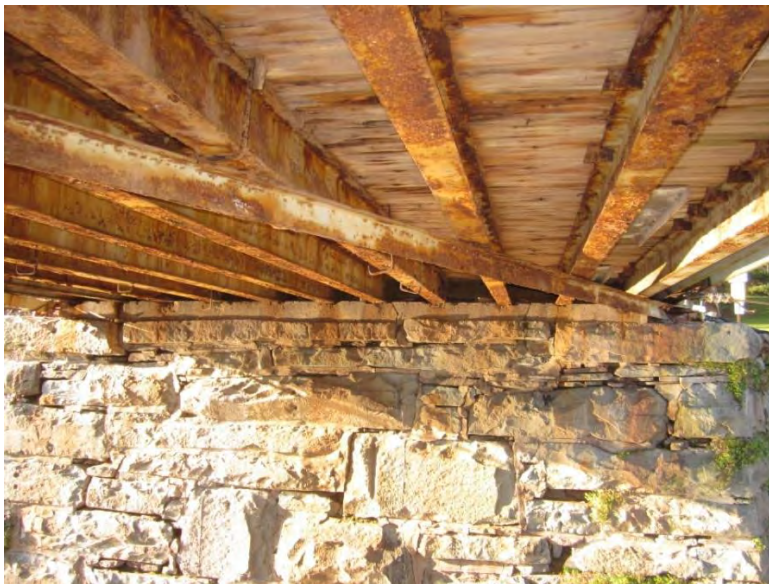
Photo 26 - Skinners Falls Bridge: Near Abutment with wide mortar joints with deep voids at the top half

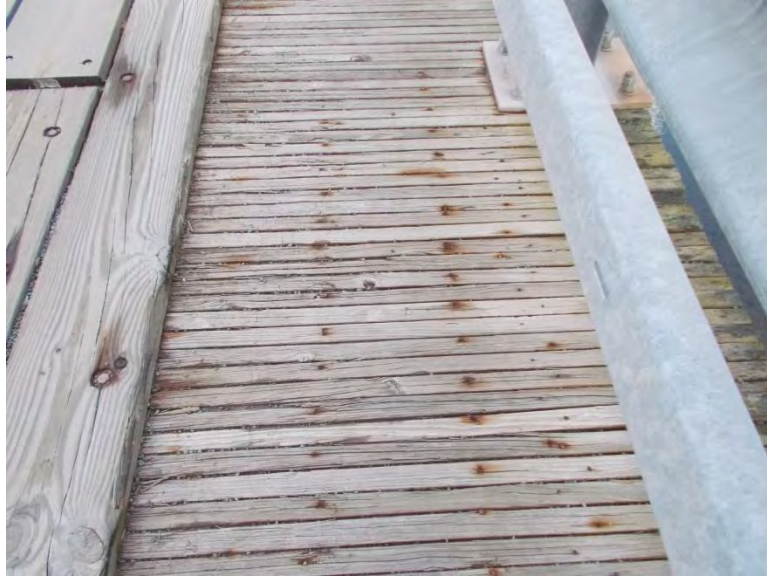
Photo 33 - Skinners Falls Bridge: Typical Deterioration of Left Edge of Deck.

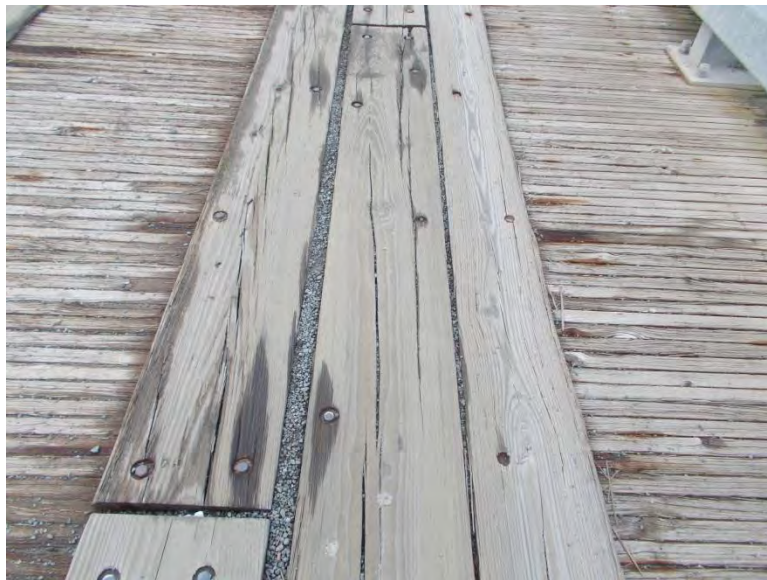
Photo 34 - Skinners Falls Bridge: Typical Cracks and Splitting Throughout Left Tread

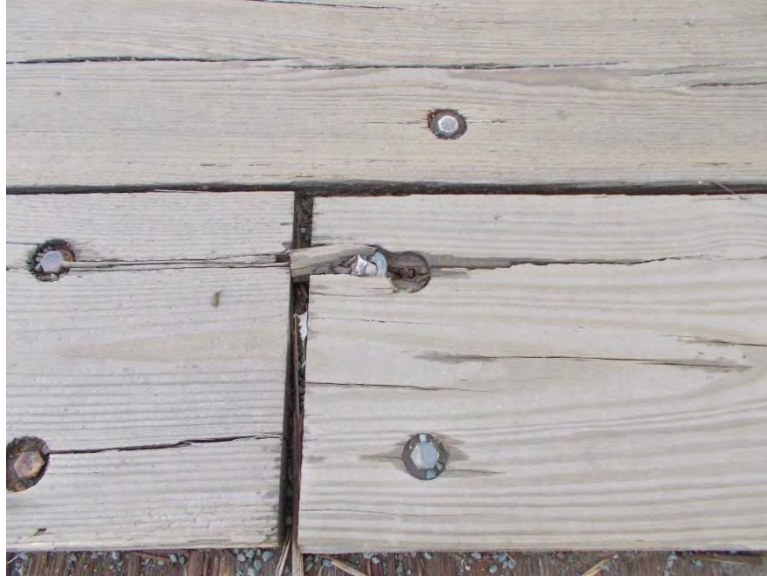
Photo 35 - Skidders Falls Bridge: Typical Damaged Tread Connection (Span 2 Shown)

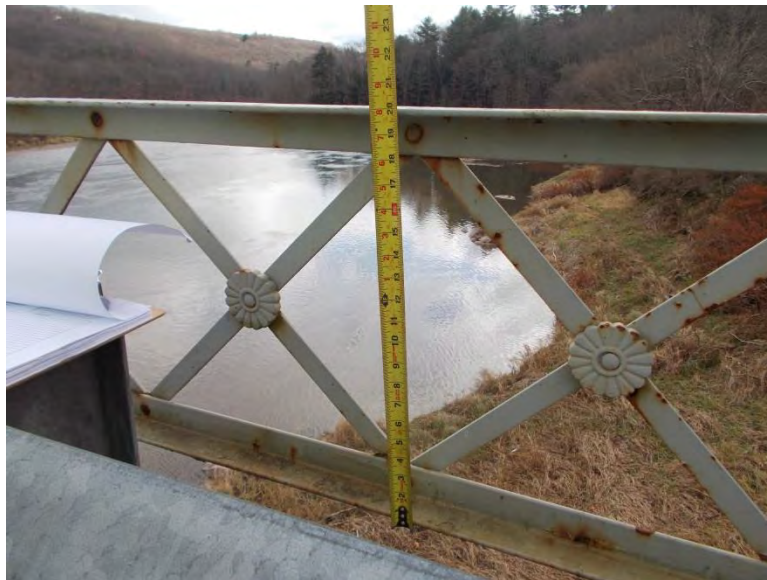
Photo 36 - Skidders Falls Bridge: Typical View of Decorative Railing

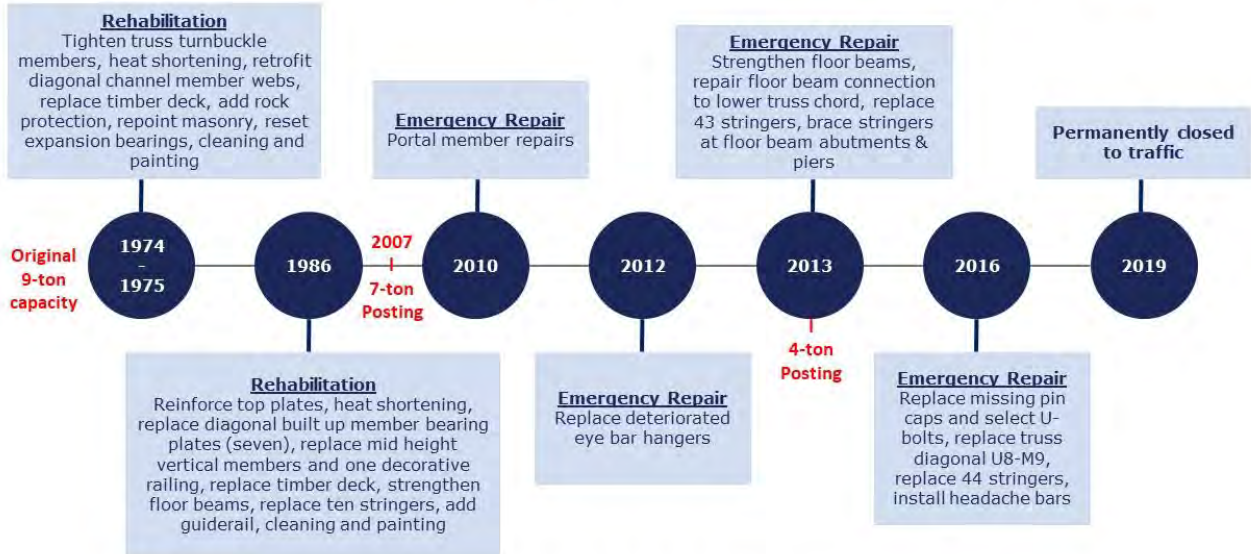
Plans for the rehab conducted in 1974-1975 were developed in 1971
